Building damage survey and microtremor measurements for the source region of the 2015 Gorkha, Nepal, earthquake

Yamada M.; Hayashida, T.; Mooney, W.; Mori, J.

Yamada M. ...[et al]. Building damage survey and microtremor measurements for the source region of the 2015 Gorkha, Nepal, earthquake. Earth, Planets and Space 2016, 68: 117.

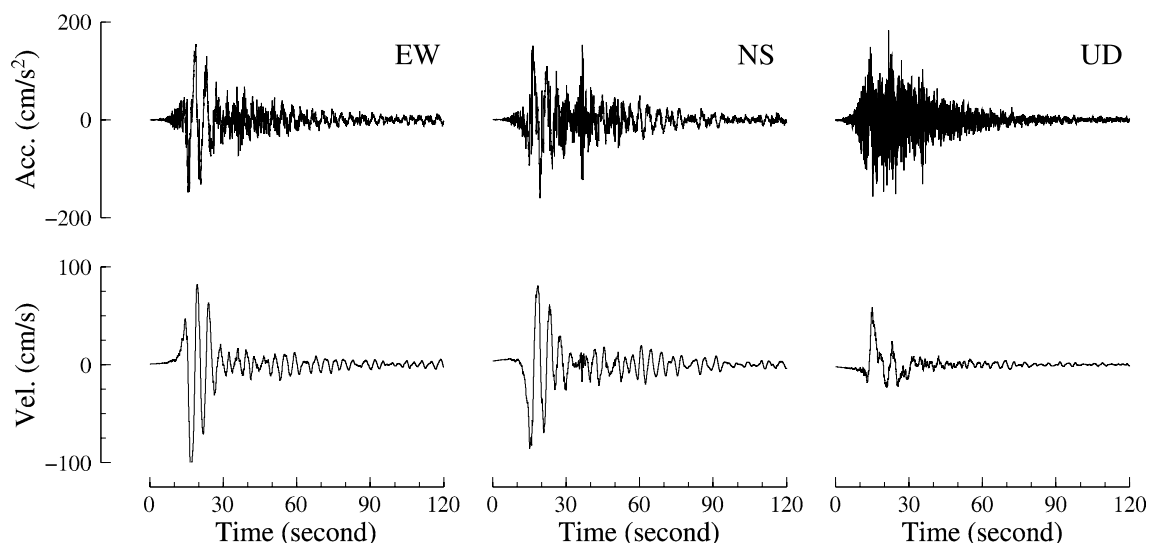
acceleration and velocity waveforms are shown in Fig. 1. The sensor records acceleration, and the velocity waveforms are obtained by integration in time domain after applying a baseline correction (Iwan et al. 1985; Boore 2001). The maximum velocity exceeds 100 cm/s on the EW component. The dominant period of the ground motion is about 5 s (see Fig. 2). Similar characteristics were observed in other seismograms recorded in the valley (Takai et al. 2016). As a comparison with ground motions that have produced severe damage in Japan, we show a record from the 1995 Kobe earthquake in Fig. 2. This recording shows predominant periods of ground motion of 1 to 2 s, whereas the KATNP record has a predominant period that is unusually long period (5 s). This long-period ground motion may be due to the response of the Kathmandu basin (Galetzka et al. 2015). Although the long-period component is large, the shorter-period component (1–2 s) is relatively small, resulting in a peak ground acceleration value of 182 cm/s^2 on the UD component.

Fig. 1 Strong motion record of the mainshock recorded at the USGS KNTNP station in Kathmandu. *Top* acceleration waveforms, *bottom* velocity waveforms

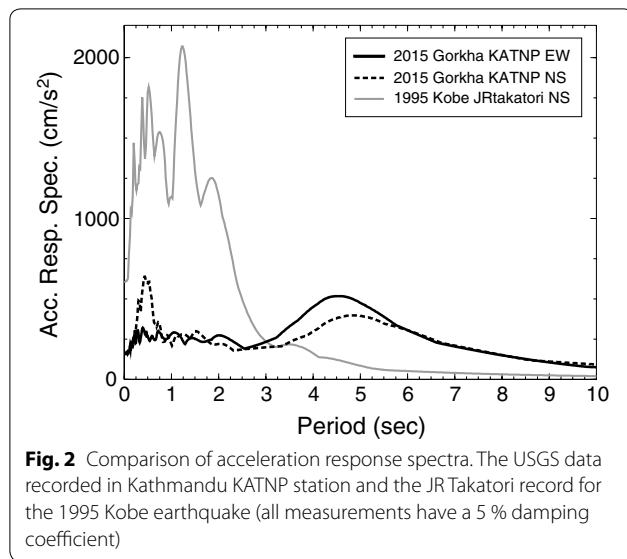
We performed a damage survey of masonry buildings and microtremor measurements on September 18–24, 2015. Our survey area spans the Kathmandu valley and regions east and north of the valley where we selected several major towns and classified the damage level of buildings. Our selected sites are: Kathmandu, Bhaktapur, Patan, Changunarayan, Nagadesh, and Piker inside the valley, Banepa, Chautara, Khadichaur, and Bahrabise to the east of the valley, and Bidur, Betrawati, and Dunche to the north of the valley. Figure 3a shows the location

The percentage of the totally collapsed buildings in each site is shown in Fig. 3a. Damage of buildings in the Kathmandu valley was localized (Bhaktapur, Sanku, and near the bus terminal in Kathmandu city), and the percentage of the totally collapsed buildings was less than 5 % in the entire valley (personal communication from the Department of Mines and Geology, DMG). East of the Kathmandu valley, especially in Sindhupalchok district, damage of buildings was severe. In the towns of Chautara and Bahrabise, the percentage of the totally collapsed

Figure 3a also shows the fatalities in each district with the background color (The Ministry of Home Affairs, Government of Nepal 2015). The distribution of the heavily damaged villages was consistent with the distribution of fatalities. The most fatalities are in Sindhupalchok district, where more than 3000 people were killed (The Ministry of Home Affairs, Government of Nepal 2015). In our damage survey, two towns in the district (Chautara and Bahrabise) were severely damaged with 40 % of the totally collapsed buildings. This suggests that the substantial fatalities were caused by the collapse of the structures.

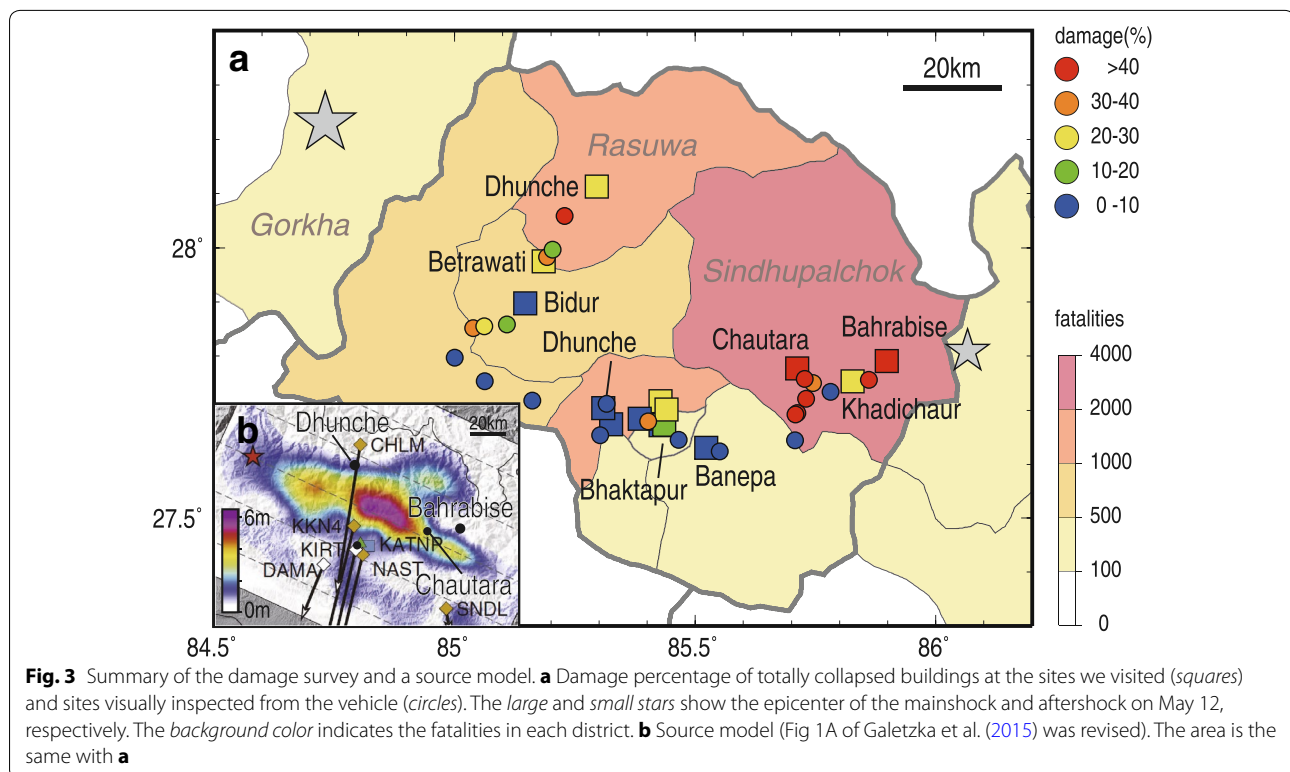
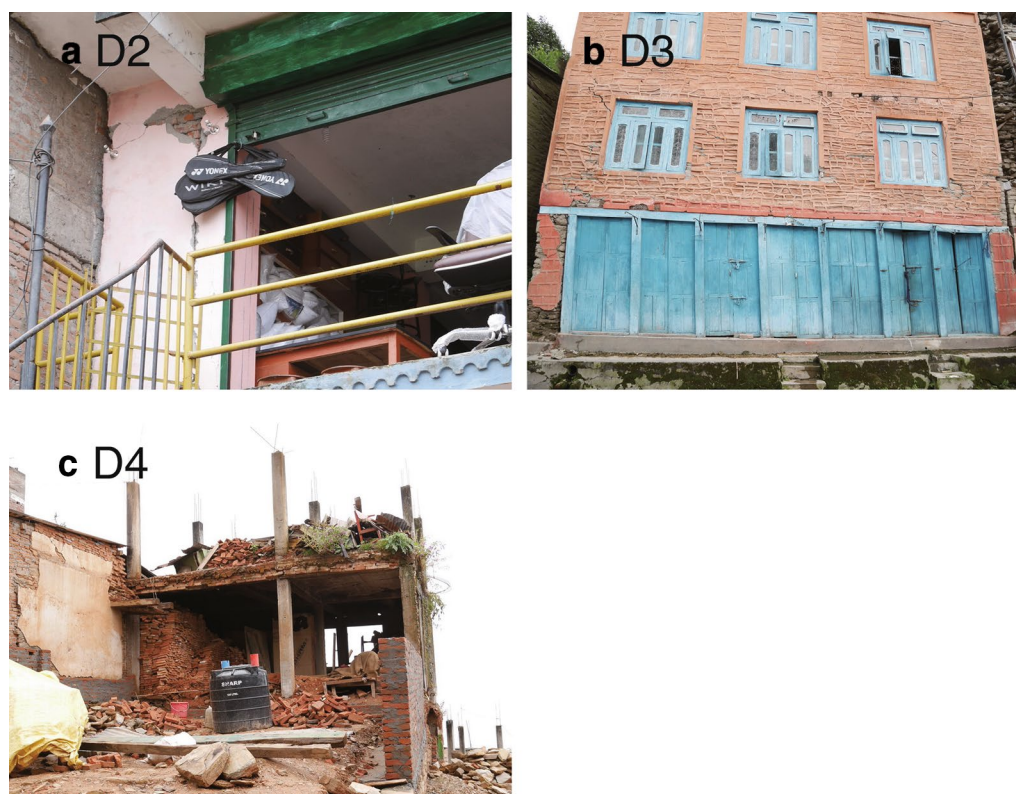
In order to estimate the percentage of totally collapsed buildings in a town, we determined the damage level of the observed masonry structures (both unreinforced and confined reinforced concrete). The damage level is divided into four classes (D1–D4) depending on the integrity of the structural elements (see Fig. 4). D1 buildings have non-structural damage such as small cracks on walls or fallen plasters, or minor structural damages. These buildings can be used without loss of function. D2 buildings have moderate damage on structural elements, such as failure of walls or cracks on columns, and require additional supports to maintain the seismic performance. D3 buildings have serious damage of structural elements, such as a tilt of the structure, and cannot be used. D4 buildings are totally collapsed or were cleared at the time of the survey. We defined D2 buildings as partially collapsed and D3 and D4 buildings as totally collapsed. Compared with the European Macroseismic Scale (EMS-98), our D2 corresponds to Grade 4 of EMS-98 and D3 and D4 correspond to Grade 5. For the comparison with the ASCE structural performance levels (ASCE41), D1 corresponds to the immediate occupancy (S-1), D2 to the life safety (S-3), and D3 and D4 to the collapse prevention (S-5).

Fig. 4 Photograph of buildings with damage levels D2–D4. **a** D2: plaster on the column was fallen down. **b** D3: permanent drift was observed. **c** D4: almost all infill was fallen down

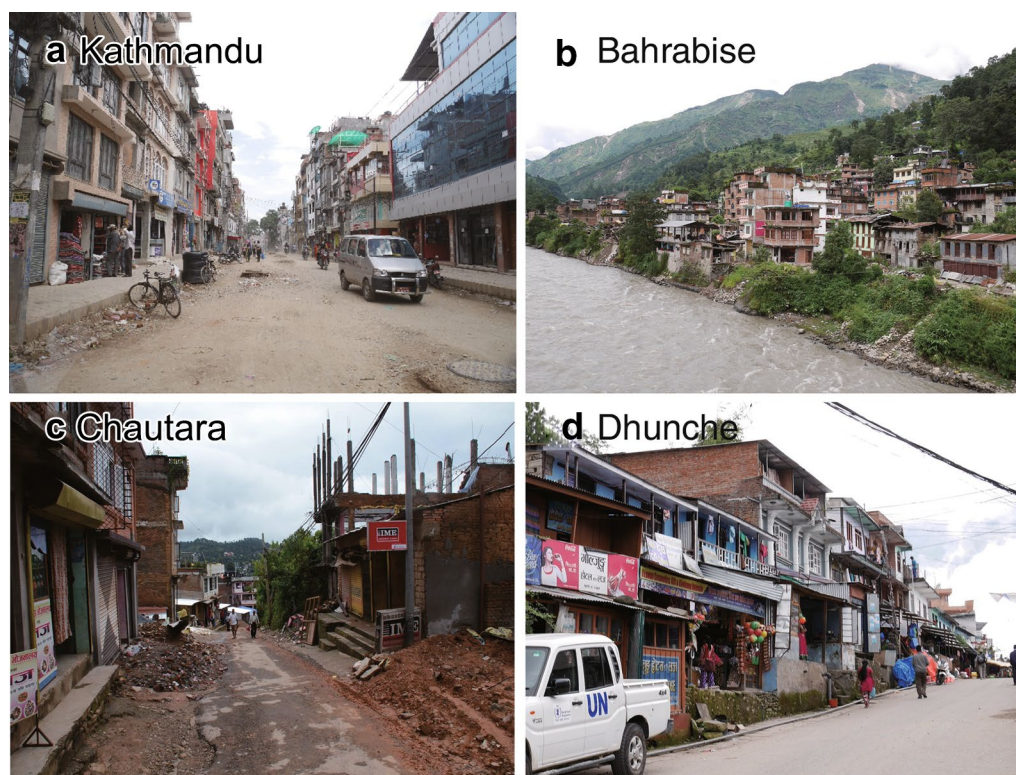
Next we focus on four major population centers (Kathmandu, Bahrabise, Chautara, and Dhunche) and describe the city properties, building types, and damage (see Figs. 5, 6).

Fig. 5 Photograph of the areas where damage surveys and microtremor measurements were carried out. **a** Kathmandu, **b** Bahrabise, **c** Chautara, **d** Dhunche

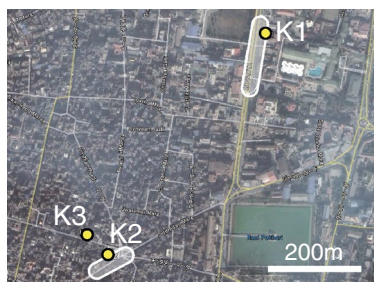
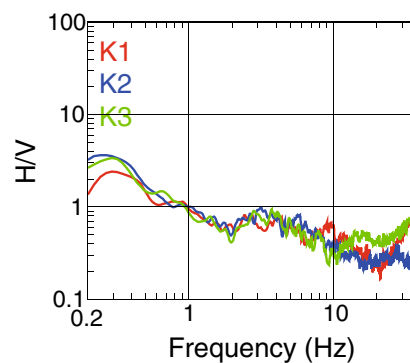
a Kathmandu

Figure 6 shows the H/V spectra of the ambient noise measured in Kathmandu, Bahrabise, Chautara, and Dhunche. The location of the measurement in Kathmandu is near the USGS strong motion station, and

Fig. 6 Location of microtremor measurements and H/V spectra in each town. **a** Kathmandu, **b** Bahrabise, **c** Chautara, **d** Dhunche. *Left* map of the surveyed area (white painted area) and location of H/V measurements (yellow circles). Google Earth was used to make maps. *Right* H/V spectra measured at the location

The H/V spectrum in Kathmandu has a single peak at around 0.3 Hz. The frequency of this peak is consistent with the past studies (Paudyal et al. 2012, 2013) and reflects the velocity contrast of the deep sedimentary basin (Paudyal et al. 2012, 2013; Sakai et al. 2002). This low-frequency basin response is generally consistent with the long-period (0.2 Hz) transient waves that were excited by the Gorkha earthquake, as seen on the strong motion record (Galetzka et al. 2015). The frequency is somewhat different; however, we note that the predominant period of the soil structure tends to become longer under strong shaking.

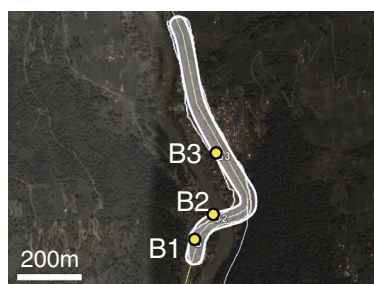
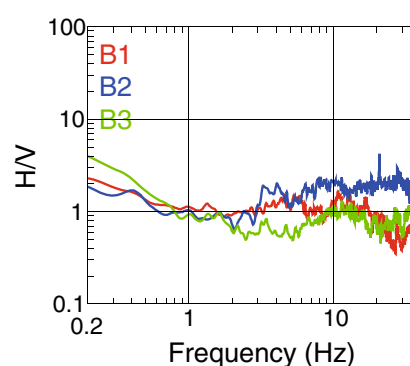
b Bahrabise

The H/V spectra in Bahrabise, Chautara, and Dhunche do not show clear peaks, which suggests that there is no strong contrast in the velocity structure. Since these areas located mountainous areas, we think the site conditions are rather stiff and effect of the near-surface amplification is probably not large (Bonnefoy-Claudet et al. 2009).
